ANNUAL REPORT  
OF THE  
WIRE DEPARTMENT,  
FOR THE YEAR 1900.

[DOCUMENT 42 — 1901.]

OFFICE OF THE COMMISSIONER OF WIRES,  
11 WAREHAM STREET, BOSTON, February 1, 1901.

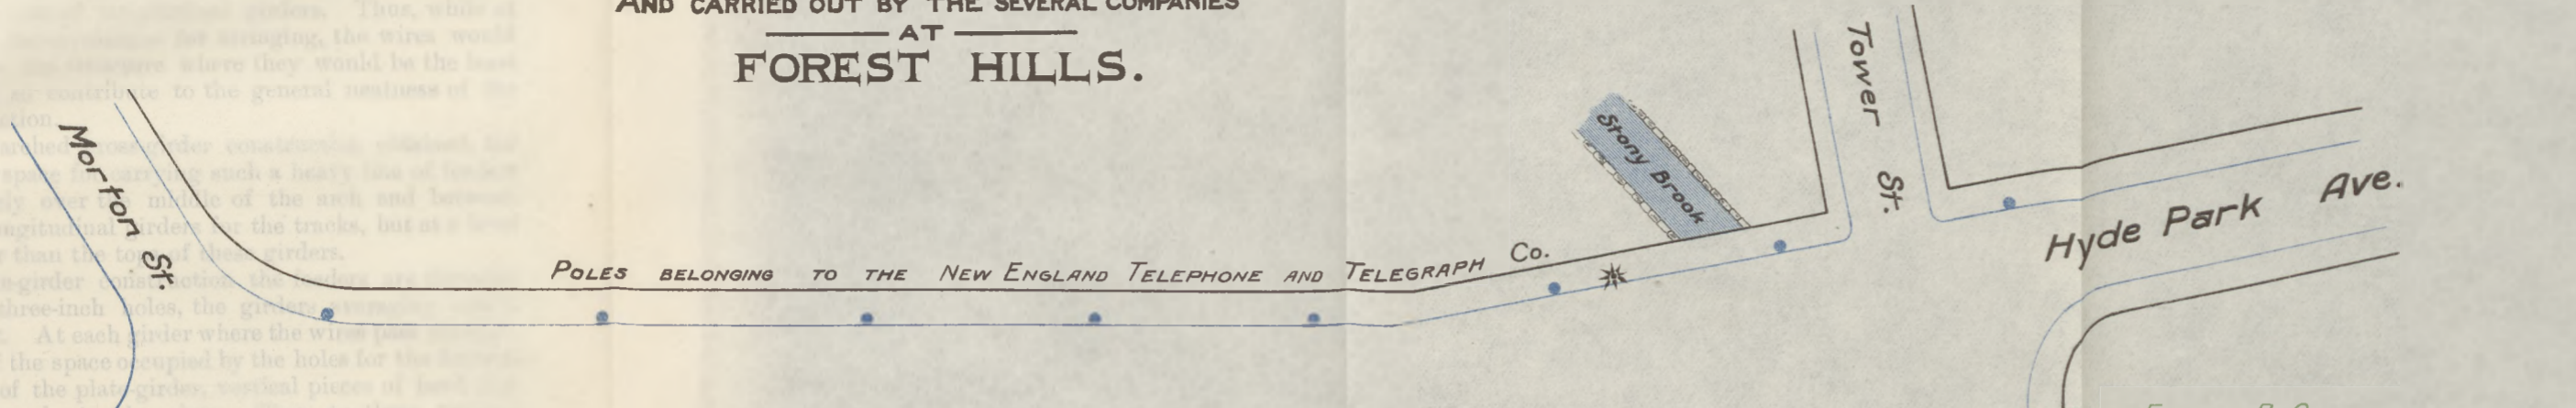
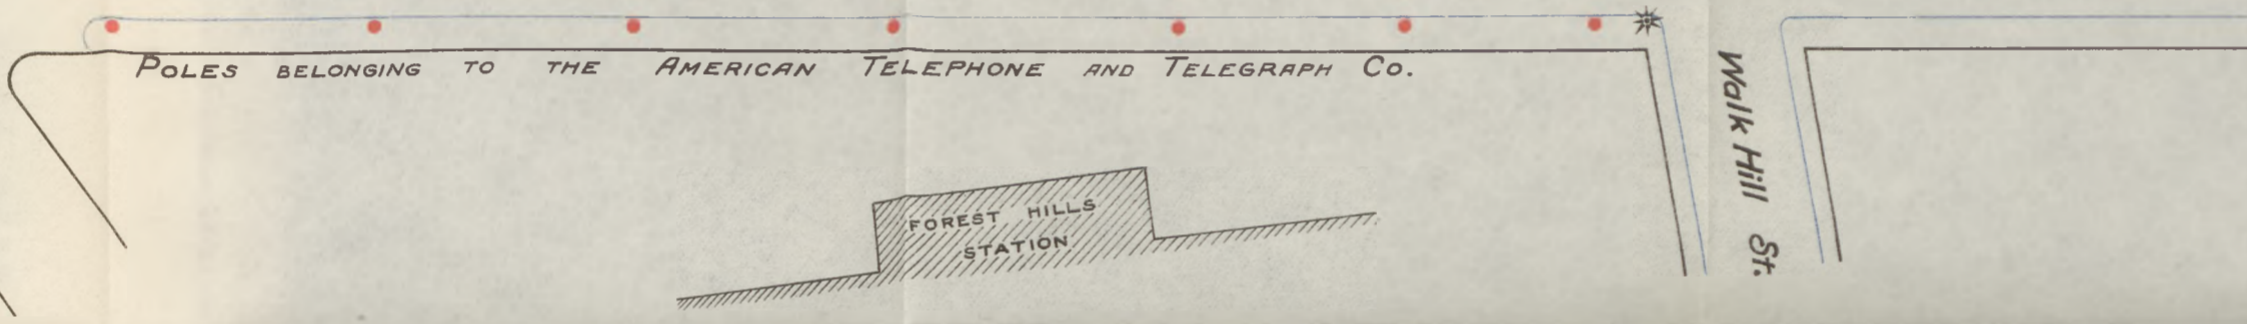
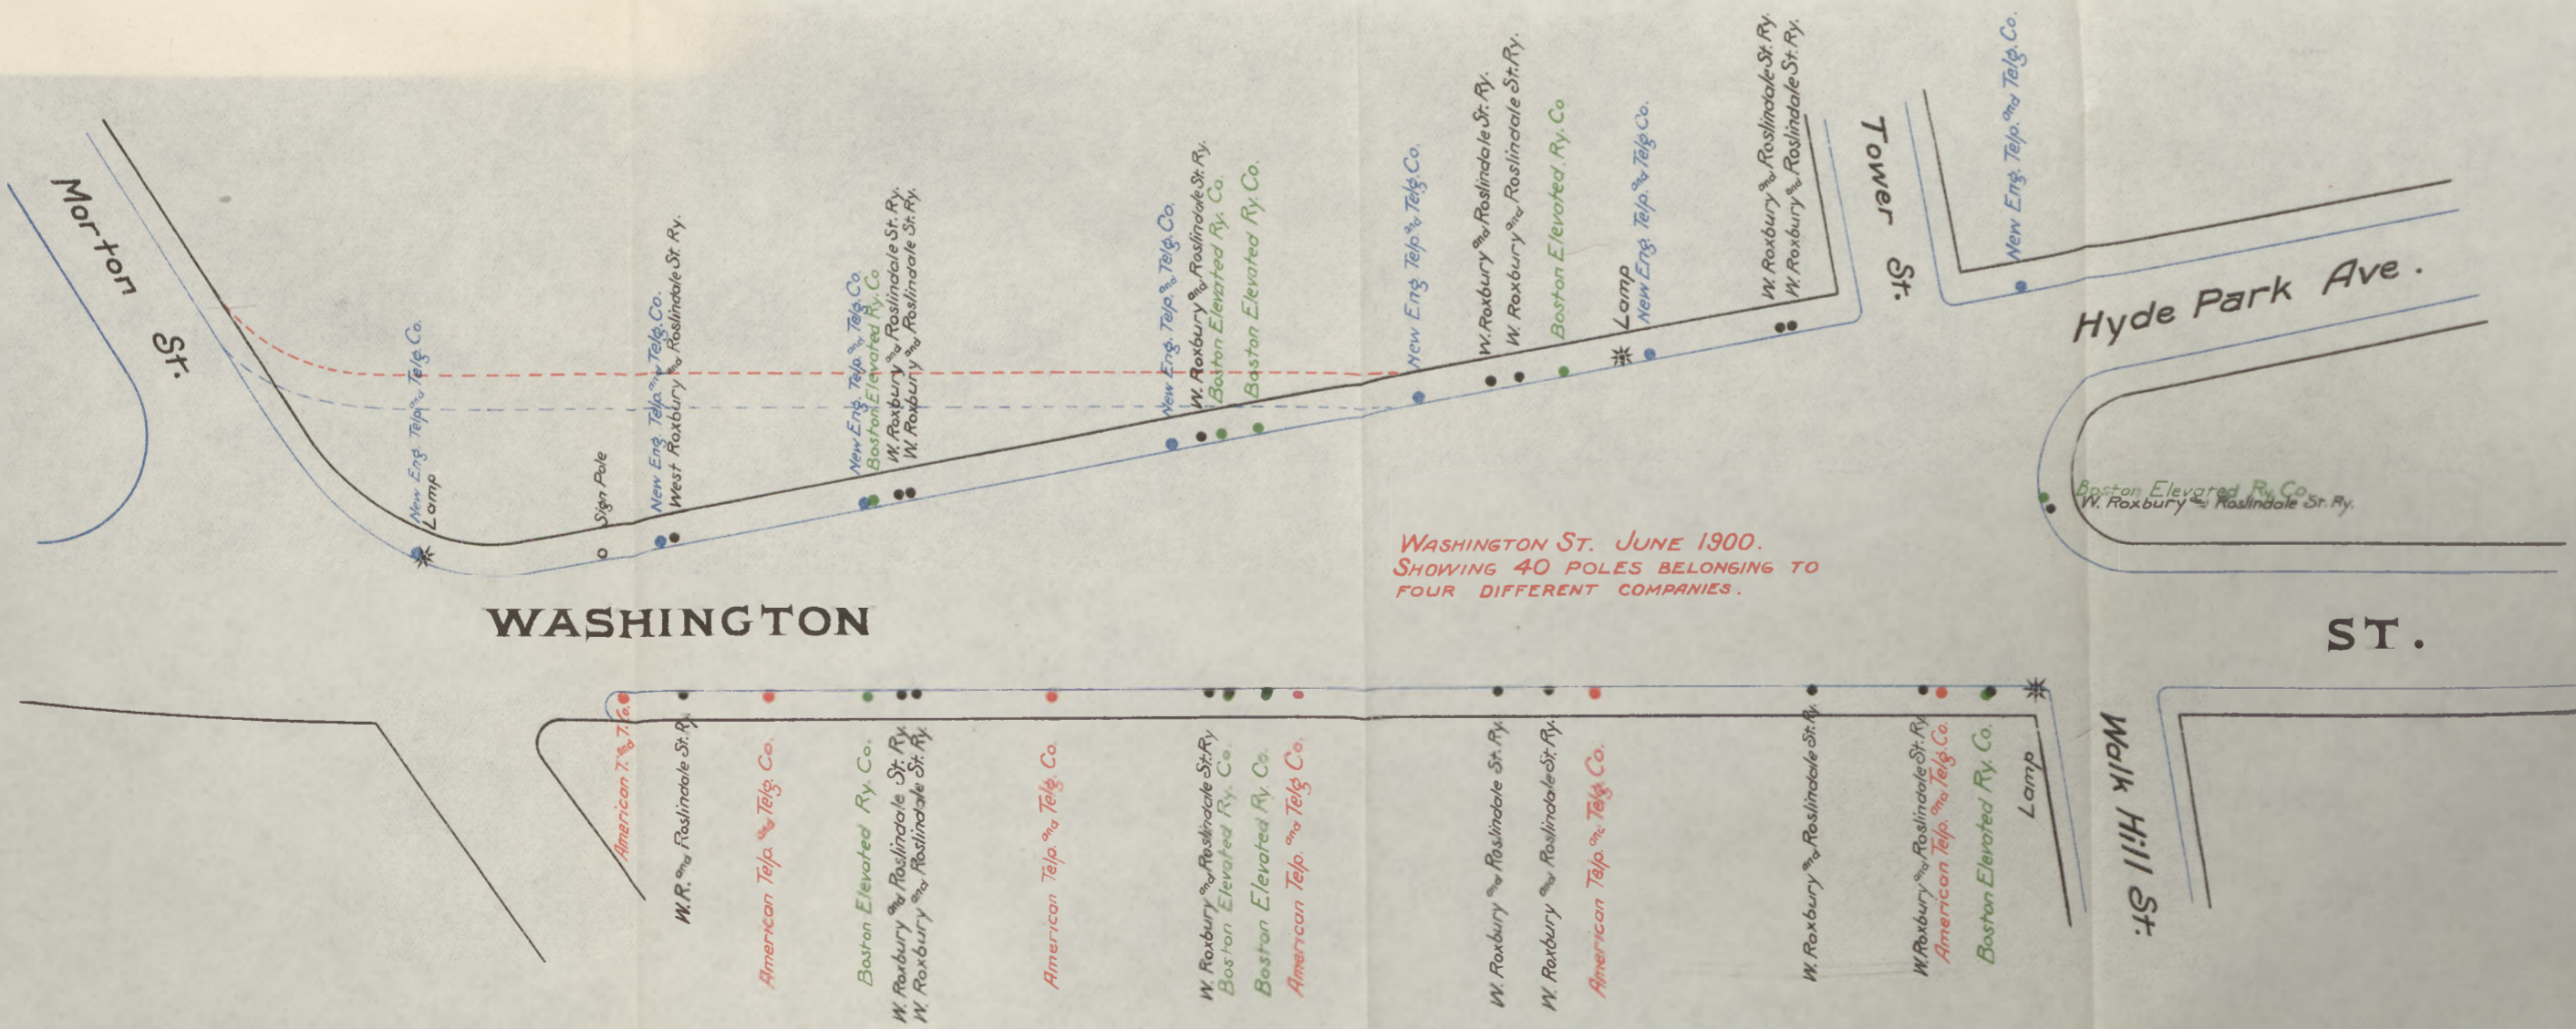
I submit with this report plans and photographs showing some of the streets of the City on which there are poles supporting heavy lines of wire. With others, a very noticeable change and improvement has been made on Washington street, at Forest Hills, request having been made by some of the companies for additional pole locations owing to the widening of the street at this point. On looking over the ground it was found that there were forty poles standing in a space of five hundred feet or less. Upon consultation with the several companies owning the poles, each using a type of their own, they readily agreed to combine and accept the plan suggested by this Department, so that to-day where there were forty poles, owned by five or six different companies, there are now but sixteen poles owned by two companies which accommodate the wires of all, and while the service of these companies has in no way been impaired, the appearance of the street has been very much improved.

*WASHINGTON ST. DEC. 31st. 1900.  
 IMPROVED, SHOWING 16 POLES  
 BELONGING TO TWO COMPANIES  
 WITH THE EXCEPTION OF ONE POLE.*

*WASHINGTON ST. JUNE 1900.  
 SHOWING 40 POLES BELONGING TO  
 FOUR DIFFERENT COMPANIES.*

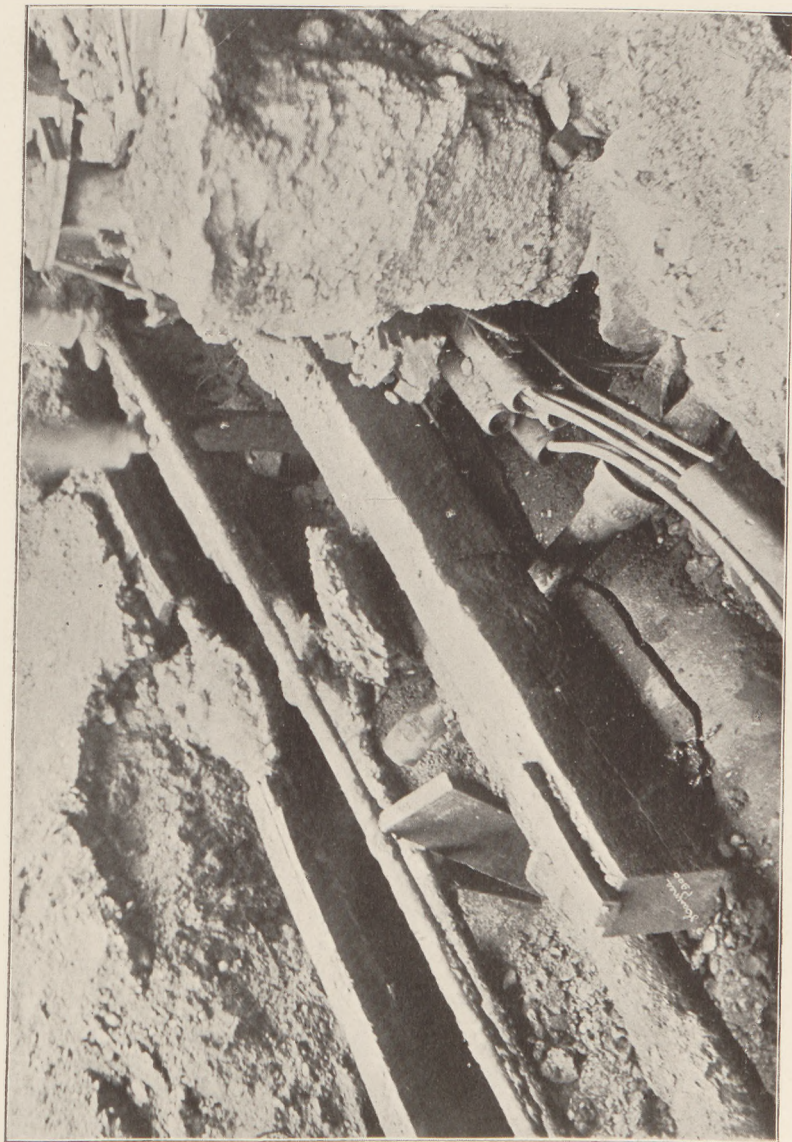
Plate No. 3.

DAMAGED CONDUITS, CORNER BOYLSTON AND TREMONT STREETS.

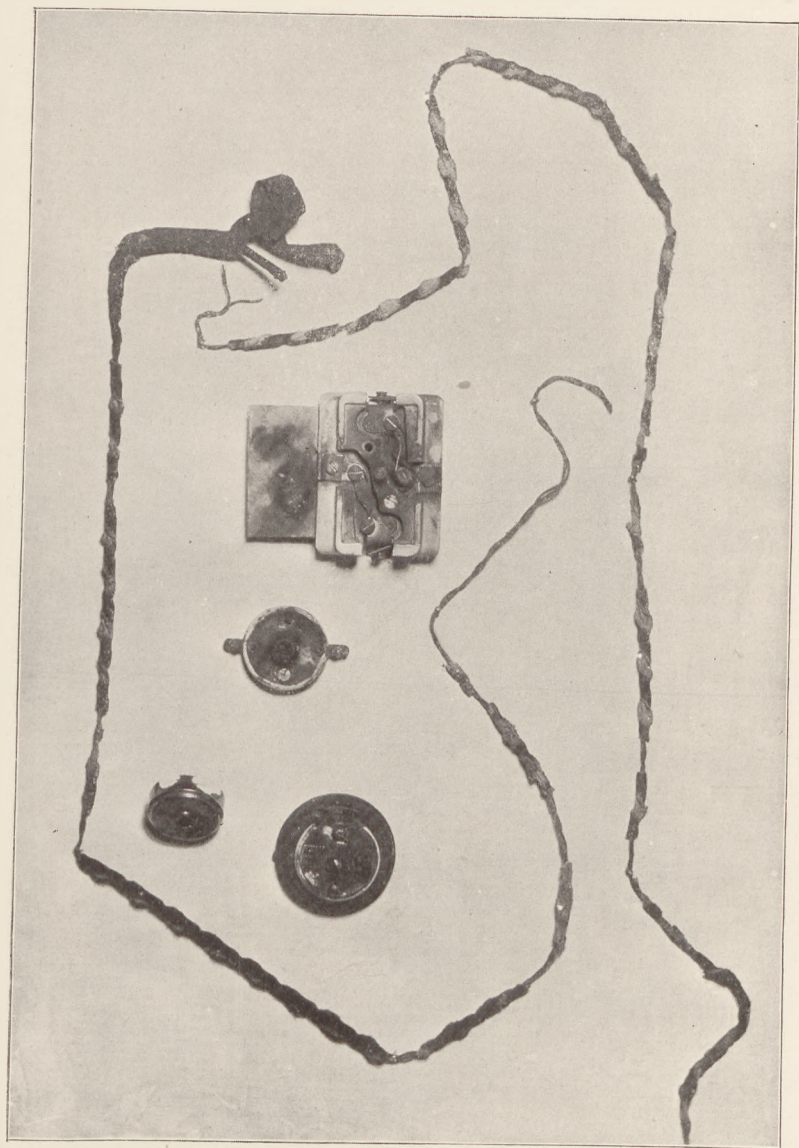
Plate No. 13.

SWITCH, ROSETTE, CUTOFF, AND PIECES OF CABLE, TAKEN FROM NO. 105 SUMMER STREET.

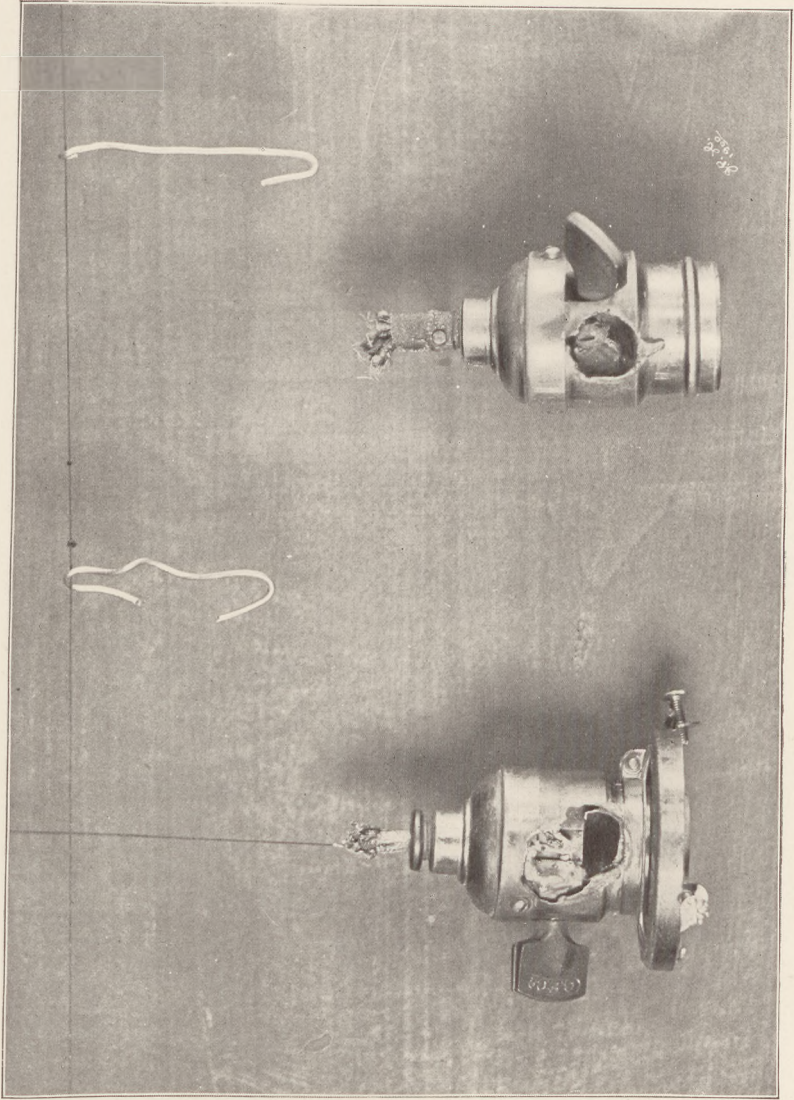
Plate No. 14.

SOCKETS AND COPPER WIRES (USED FOR FUSES).

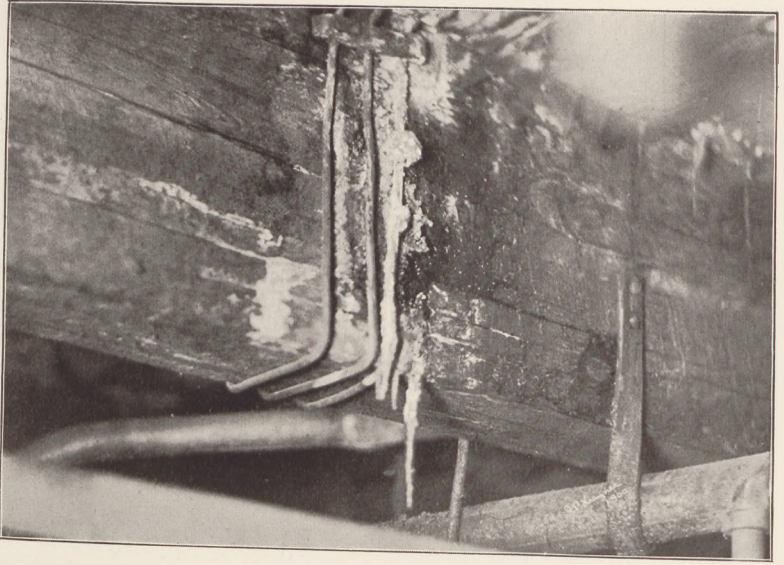
Plate No. 15.

EFFECTS OF ELECTROLYTIC SALTS ON WIRES.

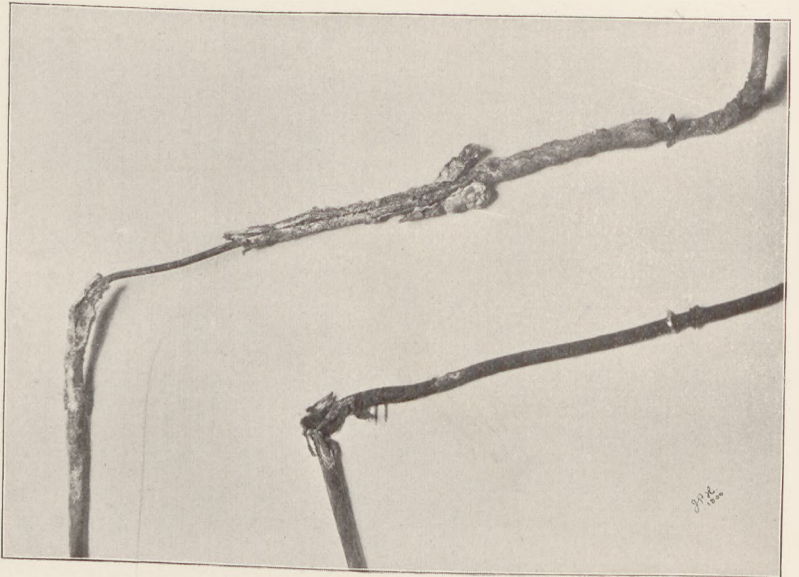
Plate No. 16.

DETAIL OF ABOVE.

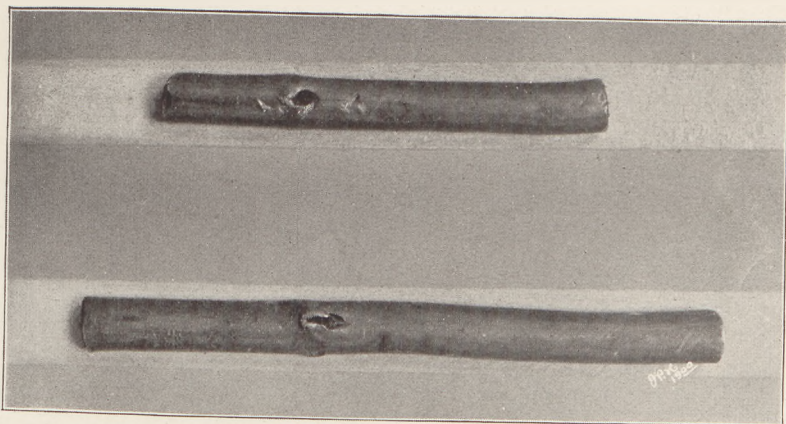
Plate No. 17.

TWO PIECES OF LEAD SHEATH CABLE TAKEN FROM A 500-VOLT  
AND A 2,000-VOLT CIRCUIT.

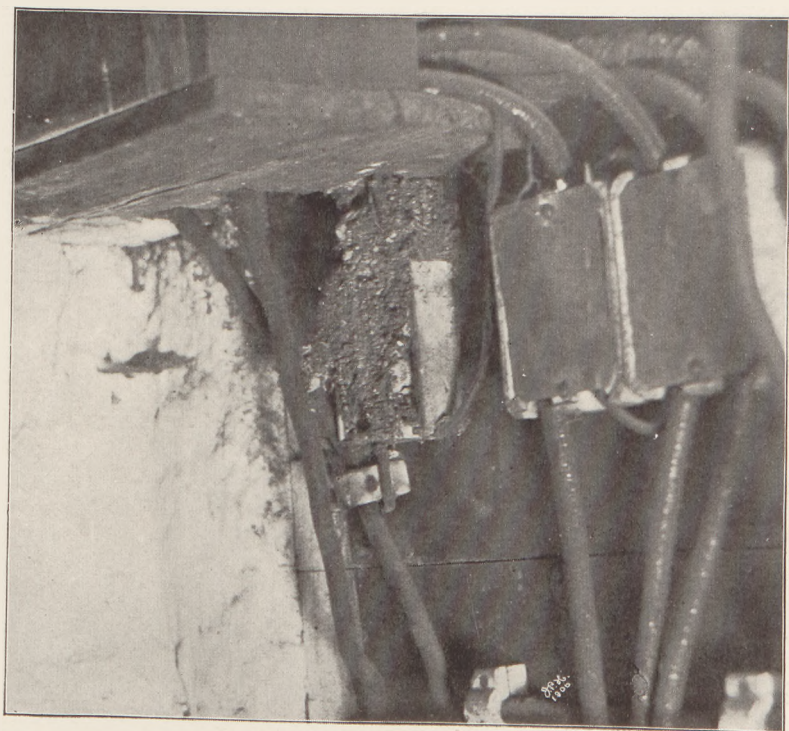
Plate No. 18.

*February 12.* At 10.30 P.M. Back Bay Station of the New York, New Haven & Hartford Railroad. A short circuit occurred in a lamp receptacle in loft of building, while watchman was attempting to remove a defective lamp. Fuse in cut-out blew, an arc was maintained across the terminals of cut-out, and insulation on wires entering cut-out was ignited and burned for several inches. Fire was extinguished by watchman without further damage. See plate No. 18.

CONDITION OF CUTOUT AS FOUND BY THIS DEPARTMENT.

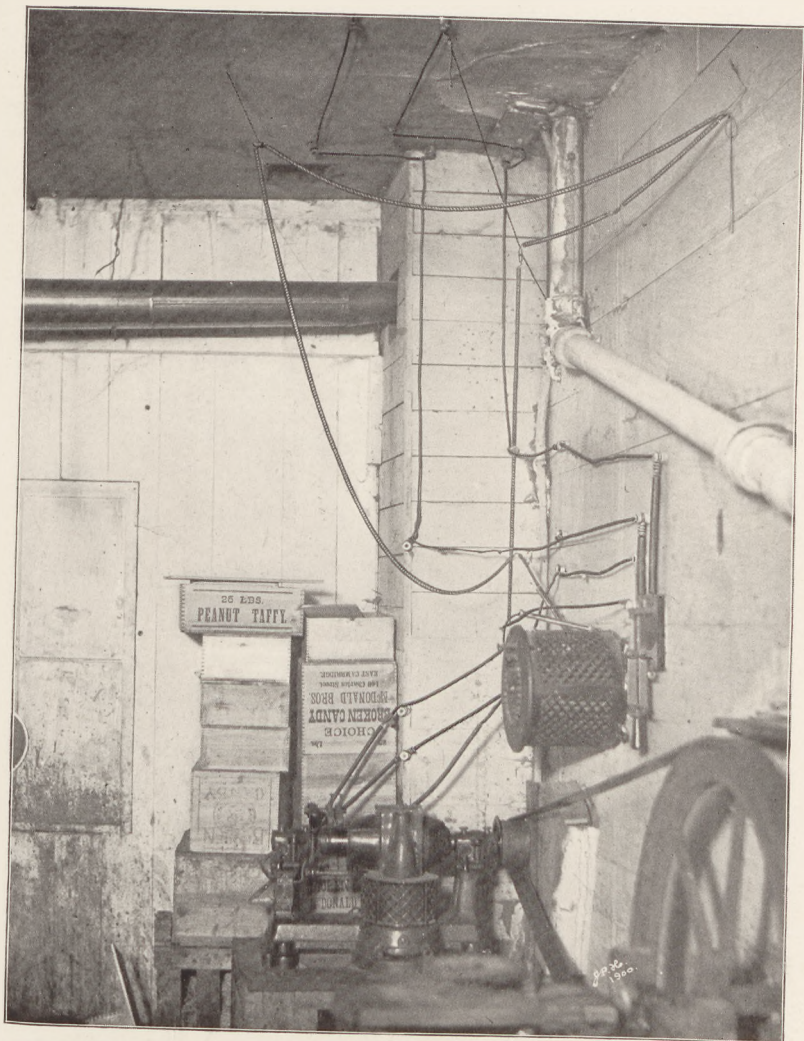
Plate No. 19.

"HOME-MADE" SPEED REGULATOR.

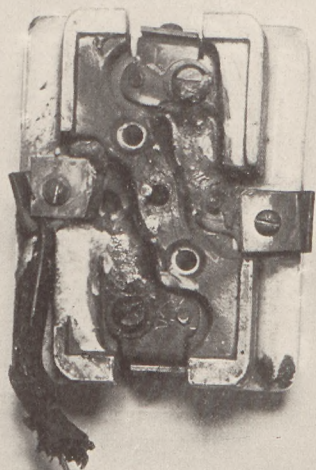
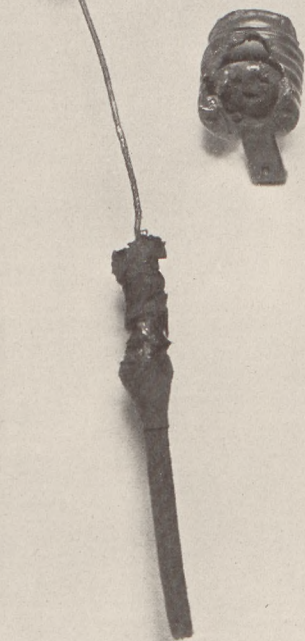
Plate No. 20.

CUTOUT AND LAMP BUTT FROM N. Y., N. H., & H. R.R. (BACK BAY STATION).

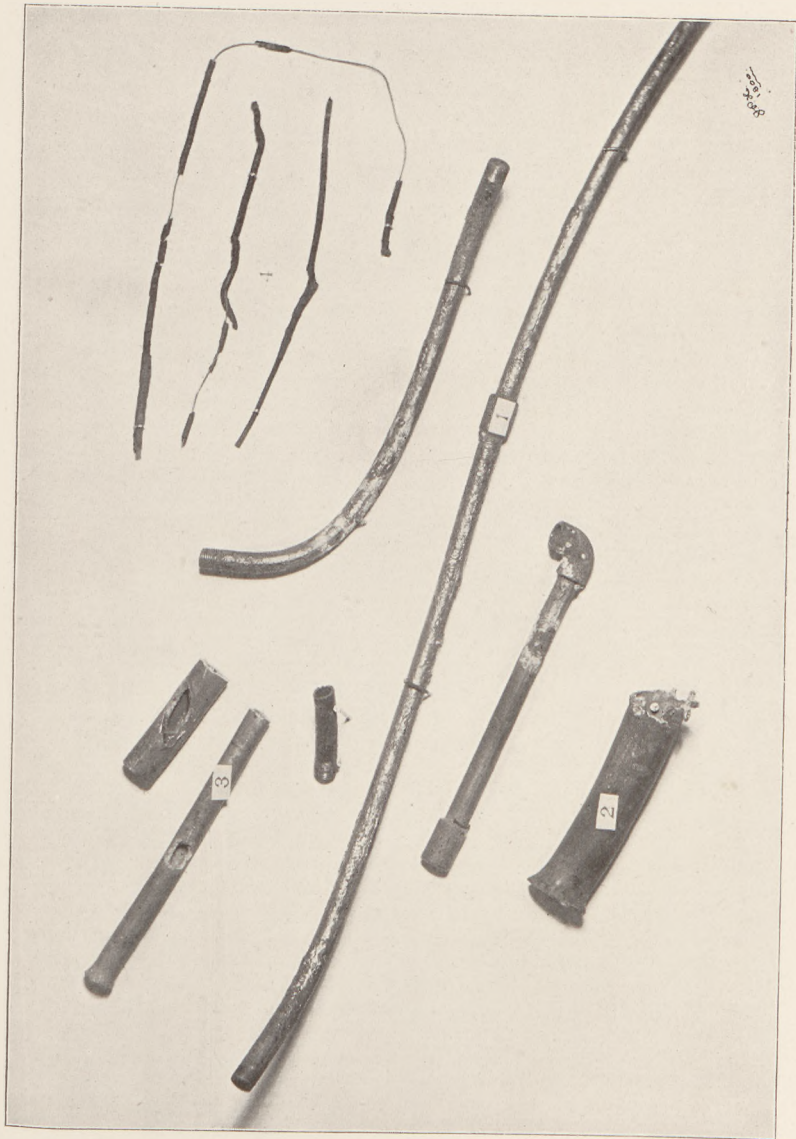
At Nos. 23-25 Pearl street. Amount of electricity passing over pipes was sufficient to melt off a  $\frac{3}{8}$ -inch gas-pipe and badly fuse  $1\frac{1}{4}$ -inch service-pipe with which the  $\frac{3}{8}$ -inch pipe was in contact, gas issuing from the smaller pipe being ignited and the flame therefrom charring and scorching the neighboring woodwork in basement. On the first floor two lead water-pipes had irregular holes melted in them at points where they were in contact with other pipes. At building Nos. 22-32 Pearl street the insulation was burned off of some ground wires which were a portion of the system of the Boston Automatic Fire Alarm Company, and which wires afforded a path for the current between the gas and water piping of the building. Moulding containing wires was also somewhat burned.

At building Nos. 48-50 Pearl street current entering same over gas-pipe was sufficient to melt off the  $1\frac{1}{4}$ -inch lead service-pipe to meter, and gas issuing therefrom was ignited. As there was nothing inflammable in the vicinity of this meter fire did not spread. Investigation showed that the source of current of electricity entering these buildings was an underground electric feeder of the Edison system, two burn-outs having occurred in same simultaneously with the electrical troubles at the buildings mentioned above. One of these burn-outs occurred opposite No. 43 and the other opposite No. 81 Pearl street.

PIPES AND WIRES TAKEN FROM BURNOUT ON PEARL STREET.
