Automatic control system - most efficient way of revitalization of older fleet maintenance workshops

Abstract -The presented paper concerns revitalization of an older workshop with minimal investing costs. The low costs are main agent of effective operation of every factory or workshop. One of main sources of extra costs are warranty repairing. It is especially seen in communication means, like trams, or metro trains. A failure of this kind of device results in many disturbances in public transport and high cost of transporting of the immobilized vehicle back to the workshop.

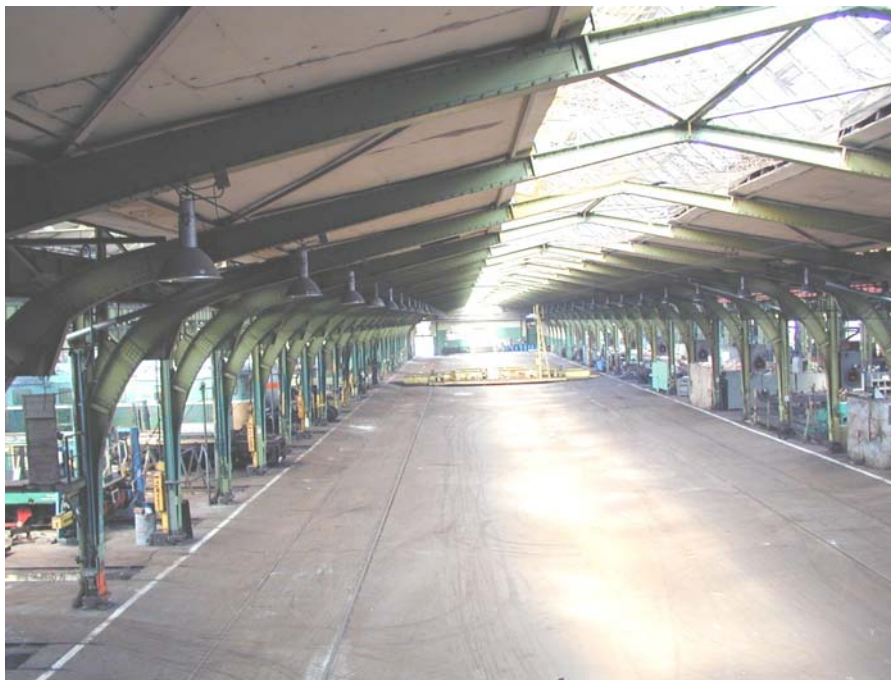
Fig. 1. Main hall of ZNTKiM

Driving unit were towed in to a repair stand in the main hall (see Fig.1.). The unit under repair was lifted up, all driving cars were removed, and motors were taken out to repair. After repair the motors had tested insulation, resistance of the windings, maximal voltage and the idle state test was performed. Than the montage process was made in reverse order. After that the train unit was tested on the trails.

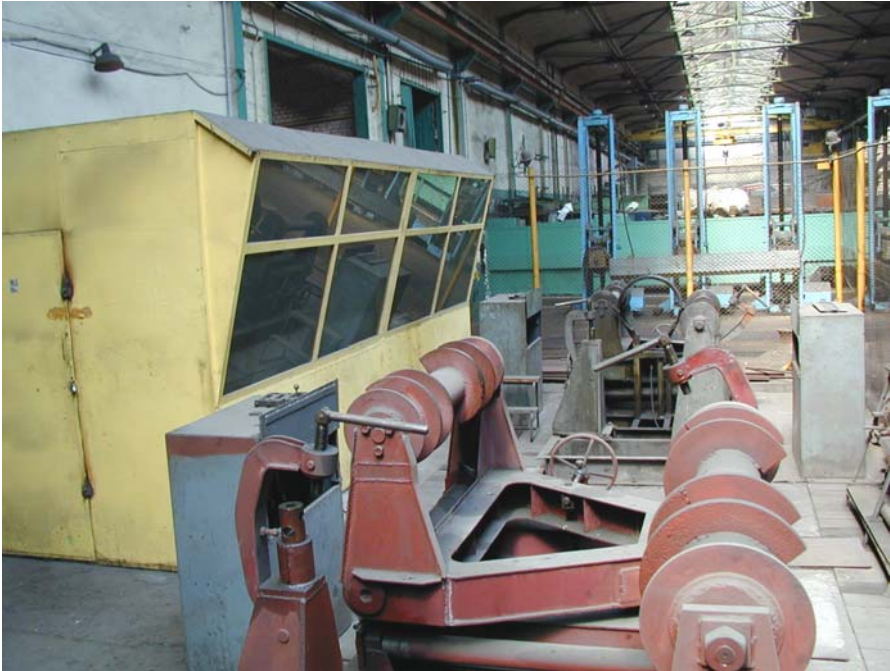
Existing electrical test station had to be equipped with an additional room for the protection of the electronic devices, both measuring and controlling. The test station with the newly erected small room for the stand is shown in Fig.2. The room was a must, as the environmental conditions on the main hall were really severe, too severe to apply computer equipment even in industrial form. The environmental conditions were severe from both, climate and electrical interferences.

Fig. 2. Room for the automatic test stand

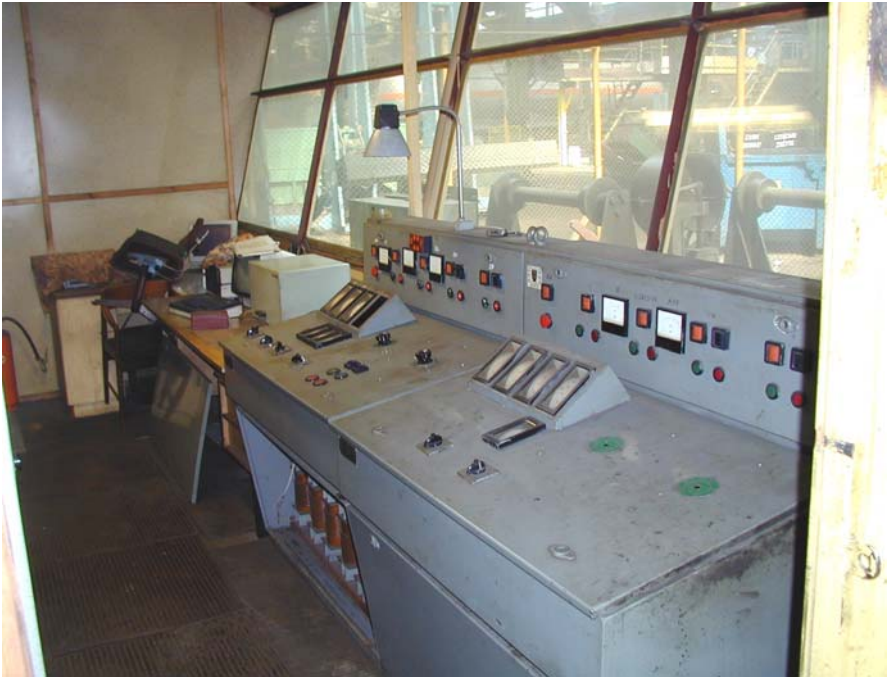
Fig. 3. The control room

Fig.3 presents control room, in which main control consol is situated and all measuring and computer equipment. The consol is the same that it had been used before computerization the stand. The consol was adapted by adding some electrical drives to existing devices, that had been set manually.

The A/D converts and optocoupler insulation barrier was placed into heavy, industrial case to additionally protect the electronic devices from hard environmental conditions. The operator has the interactive interface in the form of keyboard and a monitor. The operator's interface make it possible to type in all necessary data to the program. Results of the matching process were presented on line on the monitor. When the matching procedure finishes, the hard copy of the final protocol is printed on a printer. It is worth mentioning, the all imported data, like date and time of the test is taken from the computer system, so it is impossible to change it.
